Program Layout and Design

Structural Review

Exterior Elevation Notes: Emery Grover Building, Needham, MA

Date: **July 28, 2010**

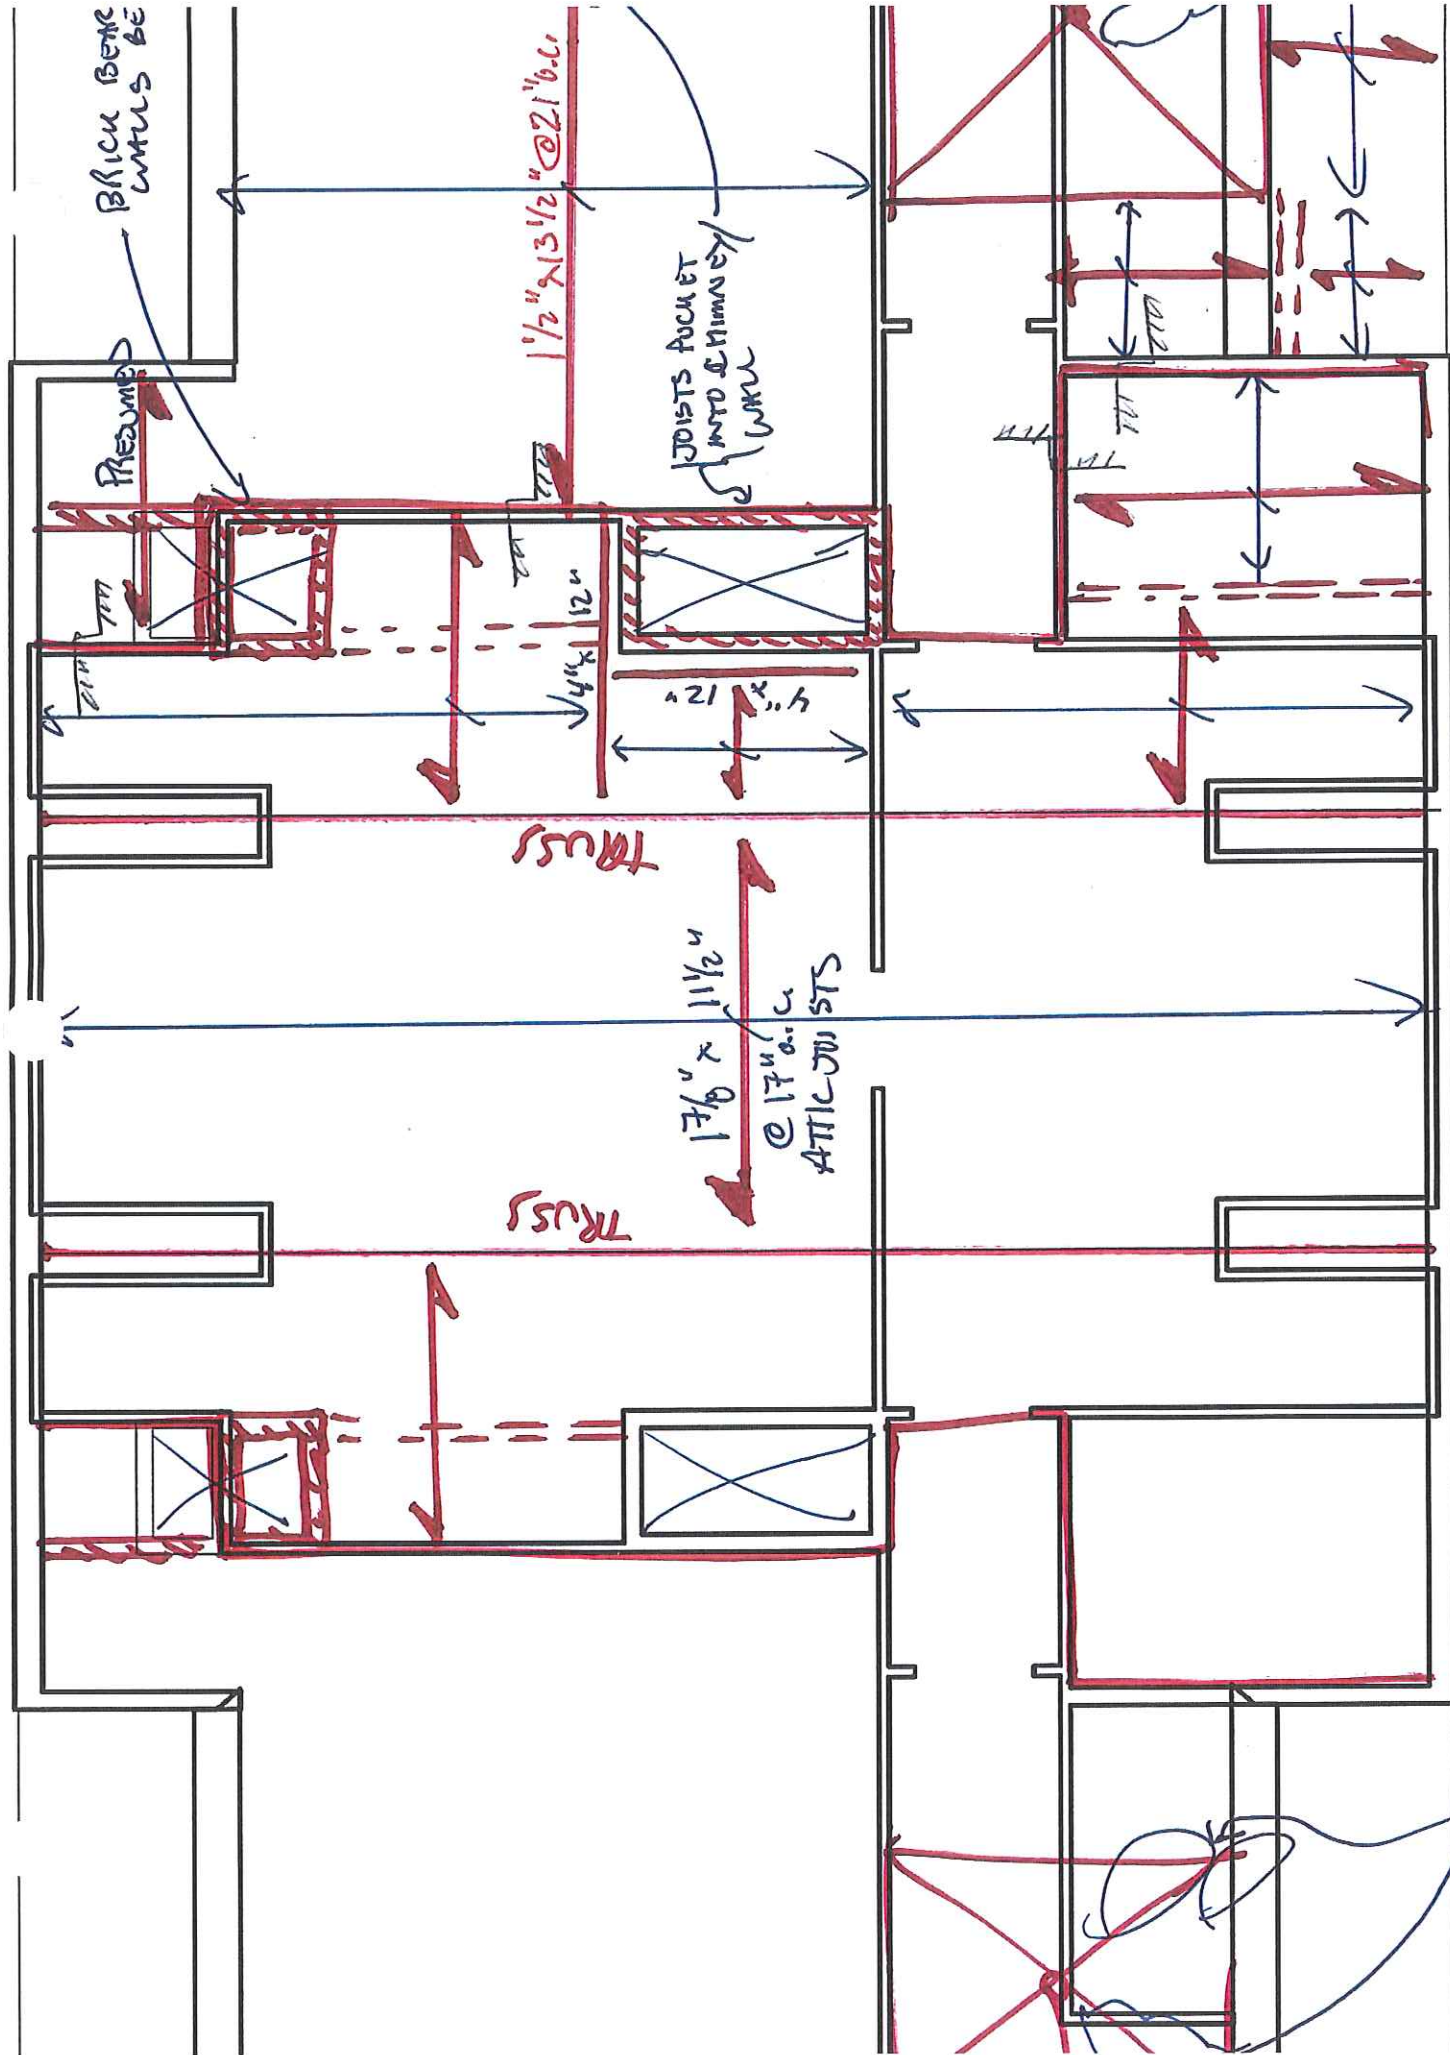
EXISTING
ATTIC PLAN

Not all attic framing was visible during Structures North's site visit. Joists and beams that we were able to observe typically had mortise and tenon connections when supported by other wood beams. The tenons were relatively small, likely only one or two inches tall. At several locations, horizontal splits in the supported framing were observed originating at an edge of tenon and extending several feet along the length of the member. Joists often had a small (1/4" to 3/8"+/-) gap between their ends and the supported member. Light gage metal joist and beam hangers, such as Simpson face mount hangers, should be installed throughout the building (all floors) at mortise and tenon connections.

The two trusses, which are the full height of the attic to roof space, and which appear to clear span the building in the east-west direction, would need further evaluation. We suspect that under a modern code analysis they would be considered overstressed and either need reinforcing or additional framing systems added to lessen the load the trusses take. **Given the general open space layouts of the proposed rooms below the trusses, we suspect the more expensive truss reinforcing option would be required to prevent new framing from interfering with the occupancies below.**

Our preliminary calculations indicate that at the center of the building, where attic joists span approximately 18.5 feet, they have an approximately 60psf live load capacity, which would be suitable for offices (without partitions), or residential occupancy. At the south and north ends of the buildings, where the spans are approximately 22 feet, the joists have only an approximately 30psf live load capacity, which is not suitable for occupancy. **We would anticipate that in order to use the attic, ALL joists would need to be sistered, and/or new beams and columns introduced to shorten existing joist spans.**

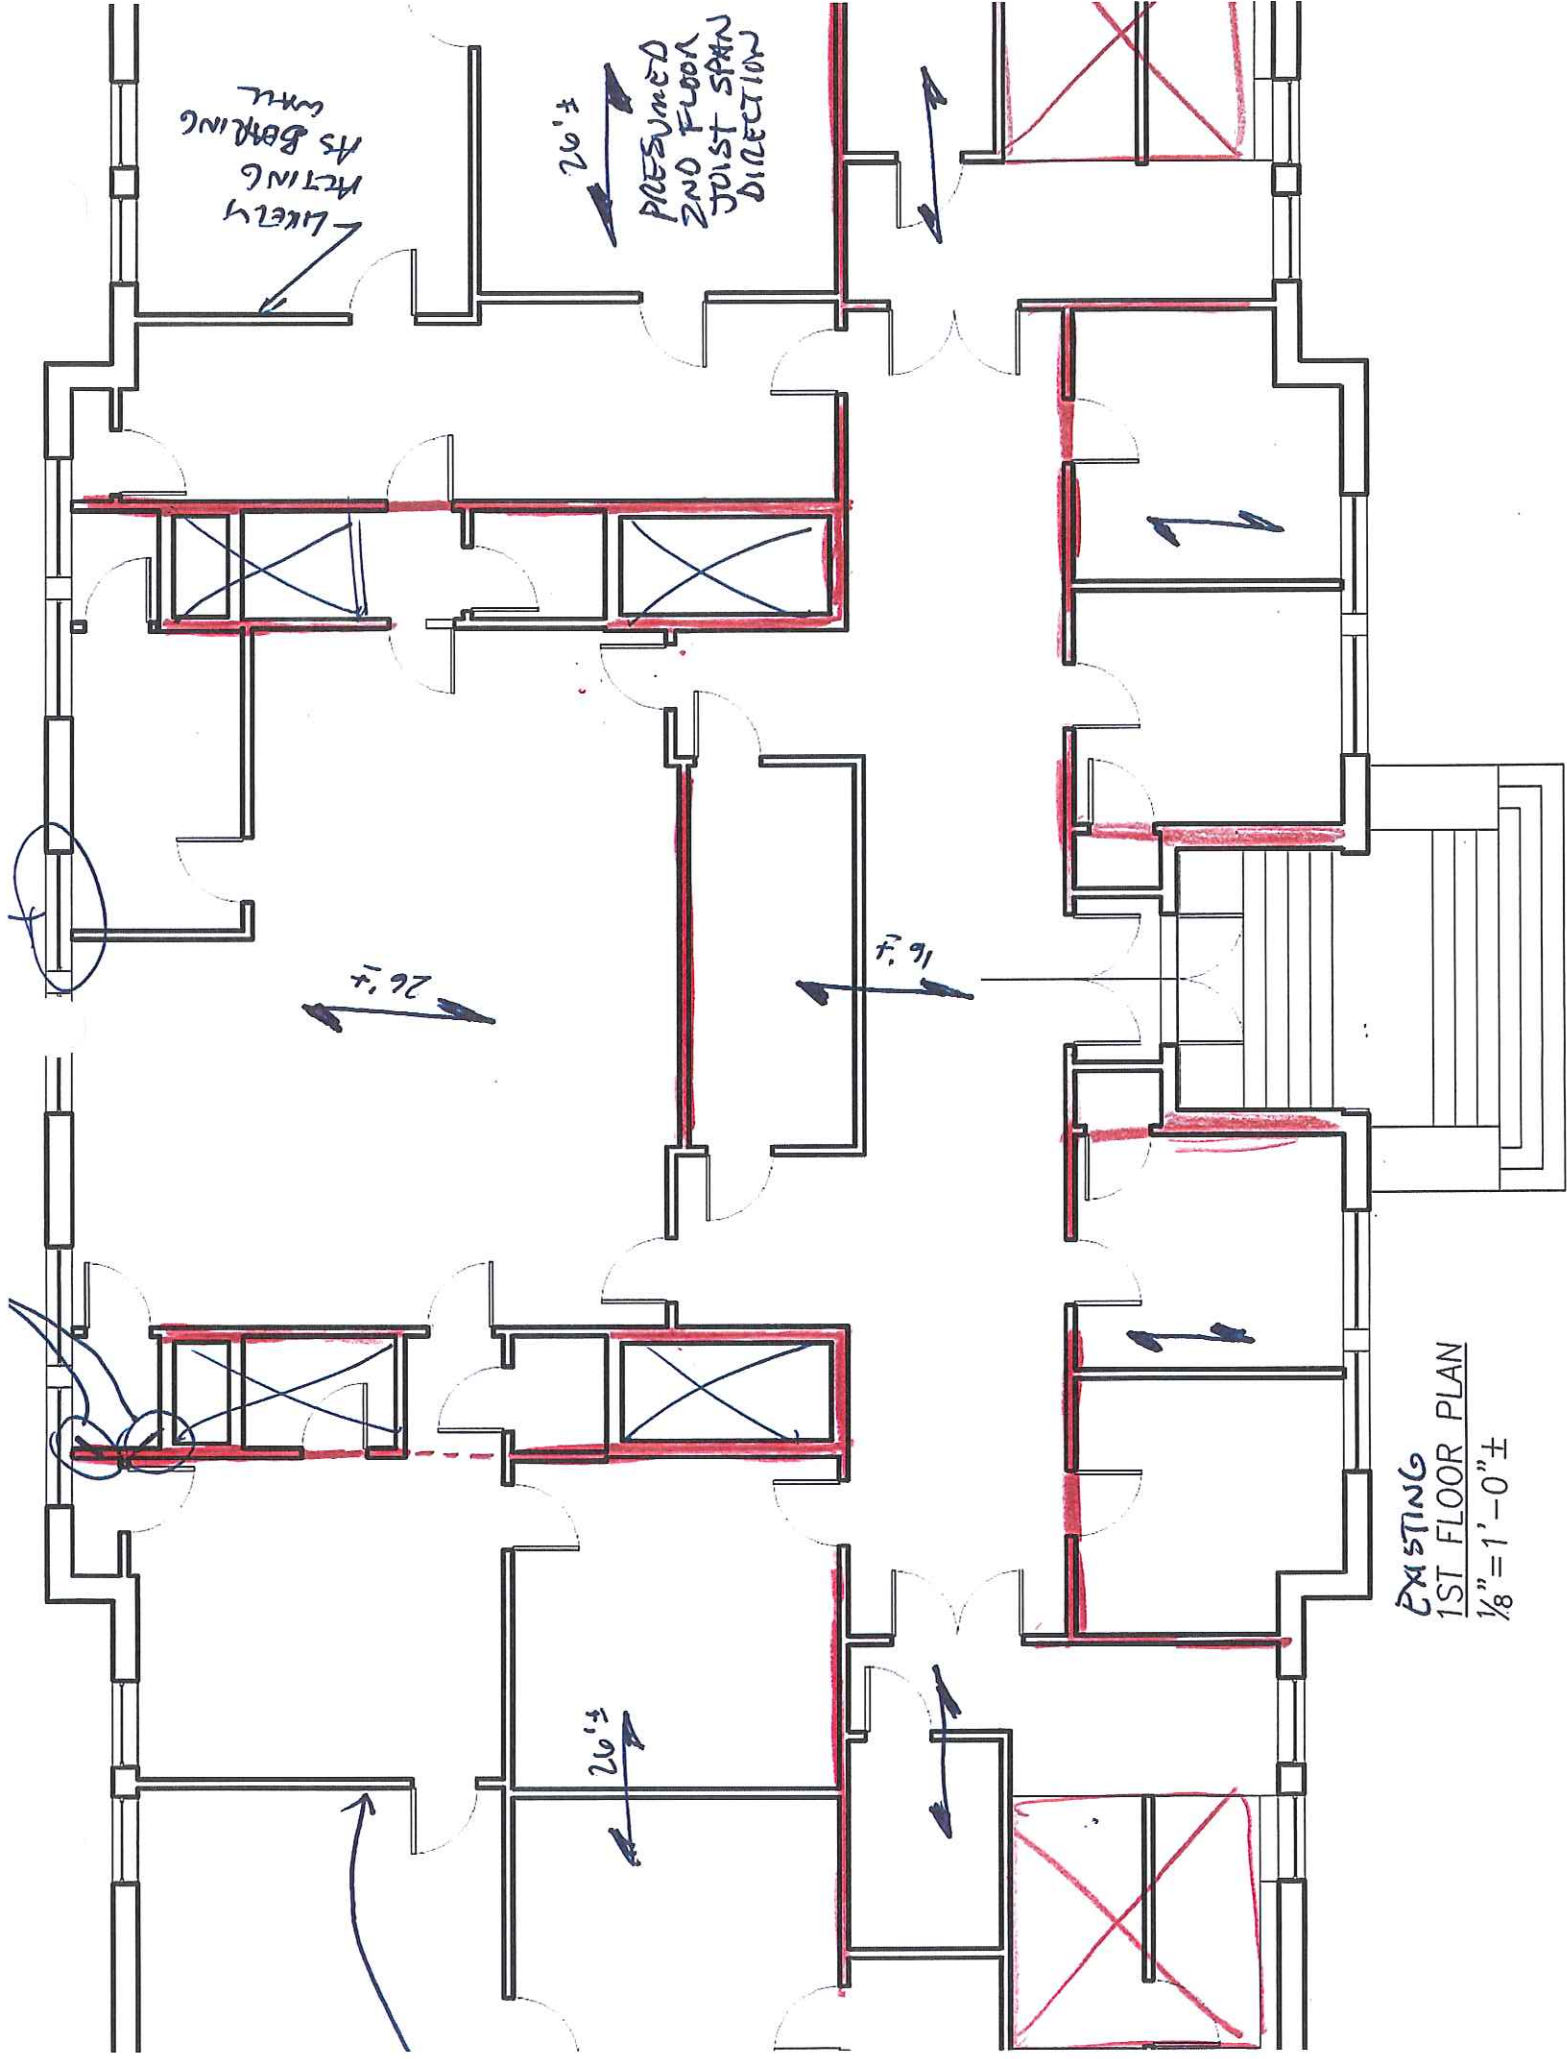
EXISTING
1ST FLOOR PLAN
1/8" = 1'-0"±

We would expect the 1st floor conditions to be similar to the 2nd floor conditions. Please refer to 2nd floor comments.

We would add that lateral loads typically increase in magnitude the lower in the building you are, until you reach exterior grade level. As such, the wide open Multipurpose room shown in option 2 would likely require a considerable amount of new lateral load resisting systems, preferably masonry shear walls, but given the layout shown, possibly a mix of masonry shear walls and braced steel frames. It may be preferable to move the Multipurpose room to the 2nd floor, and allow for more shear walls on the first floor and lower level.

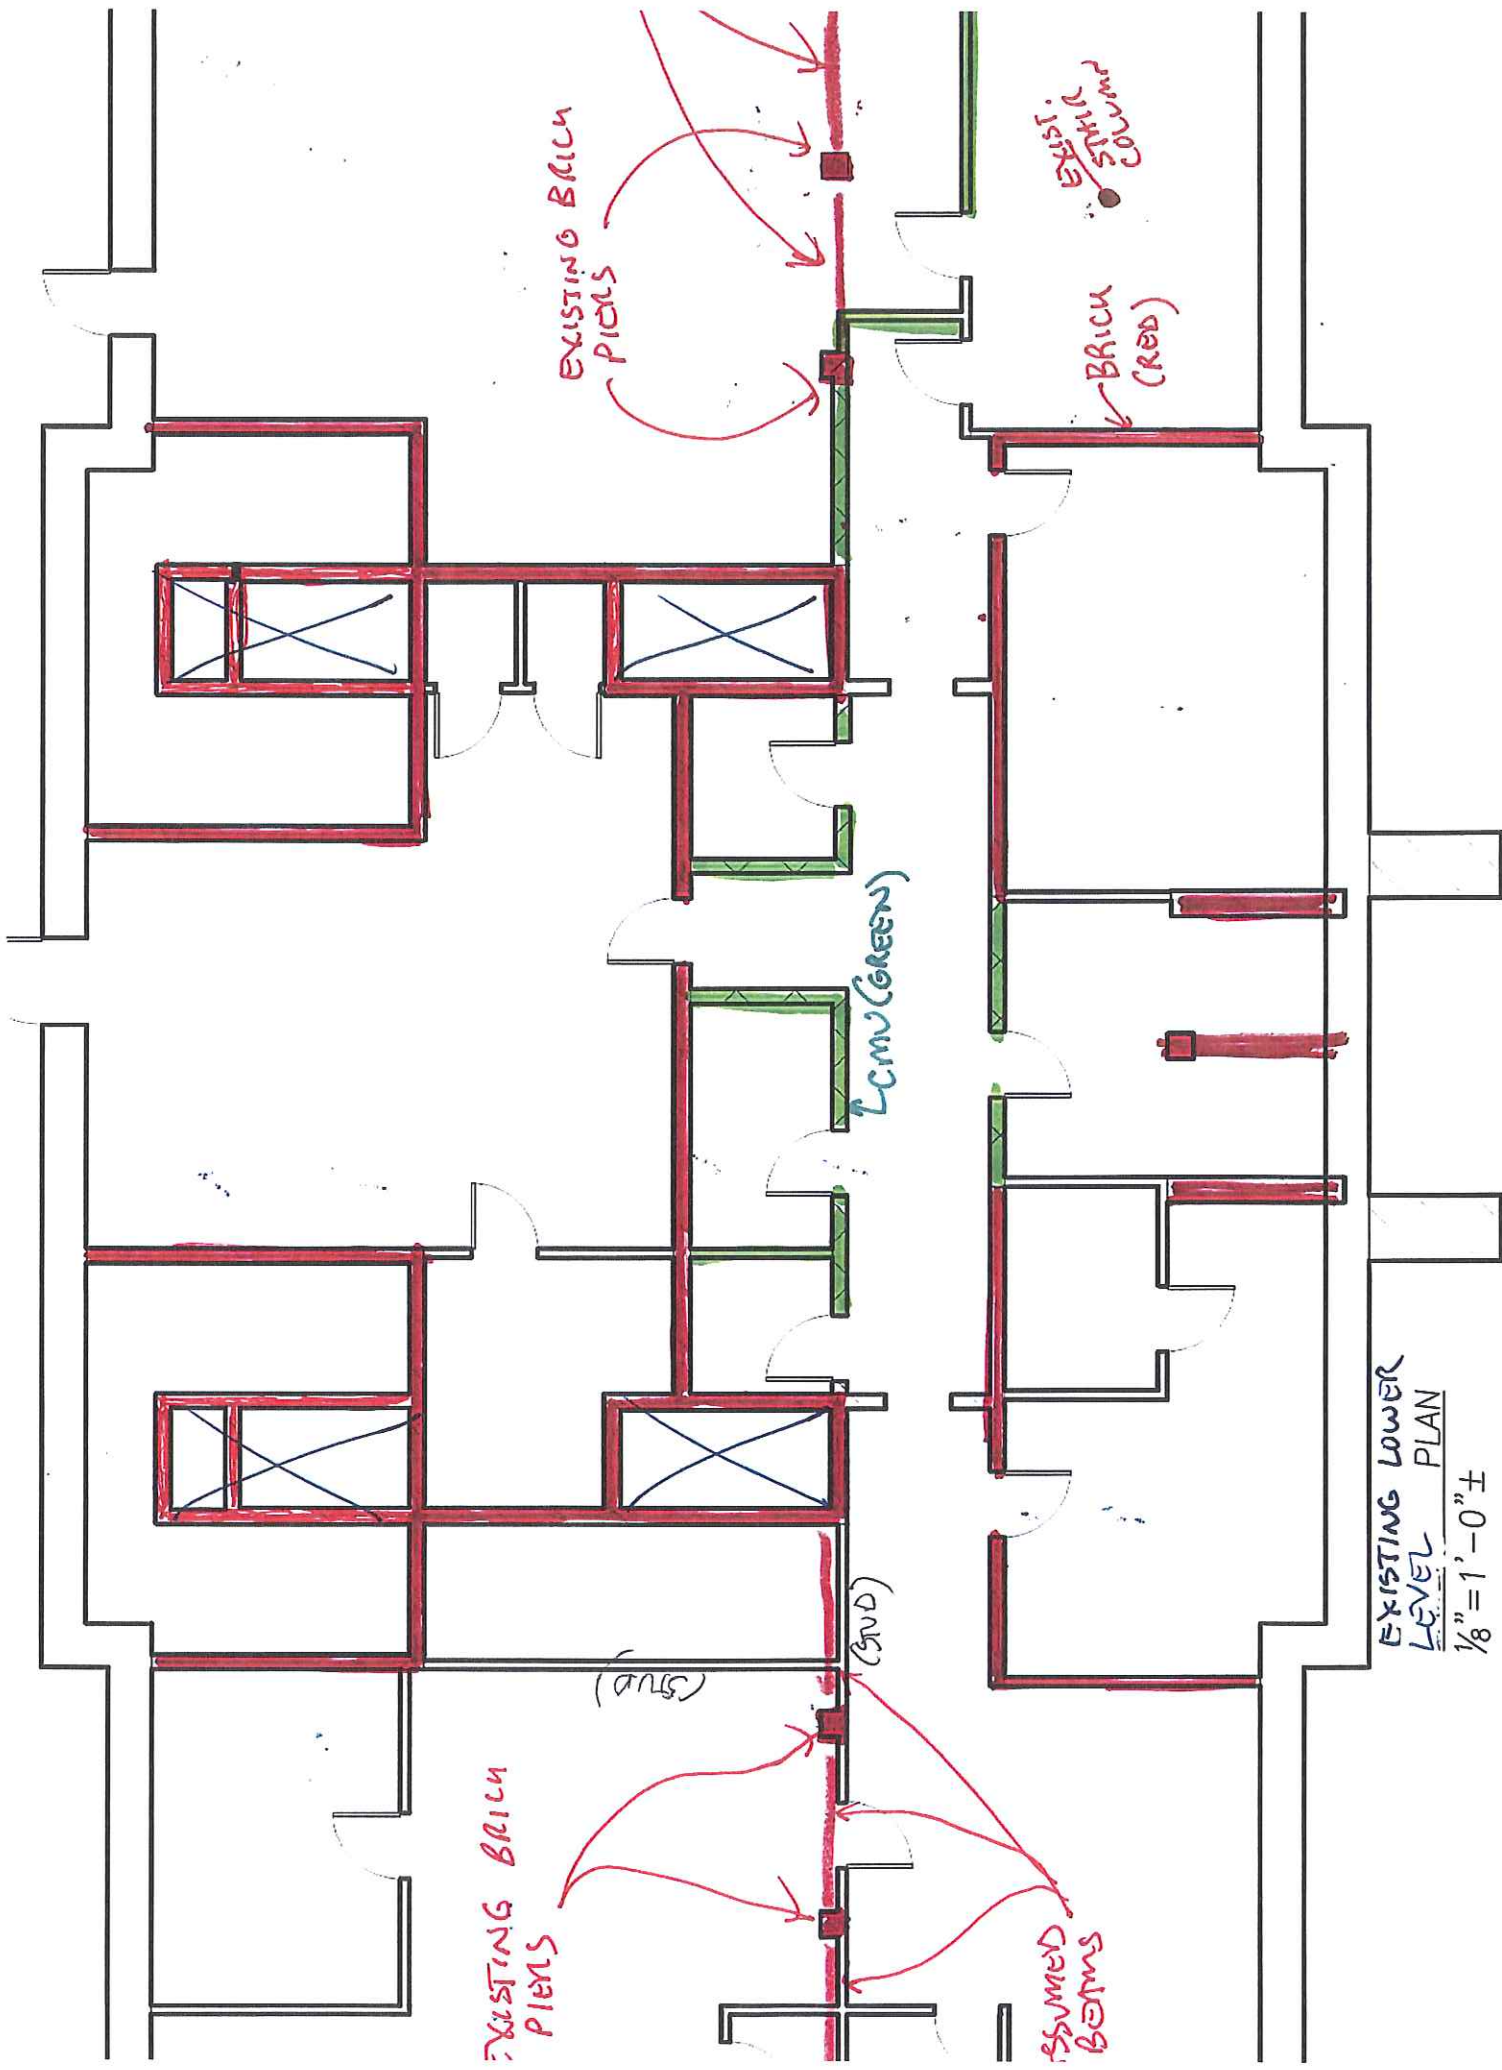
EXISTING LOWER
LEVEL
PLAN
1/8" = 1'-0" ±

We would assume that existing brick walls (noted on the attached plans) are bearing walls, and CMU (also noted on the plans) walls are later infill partitions. As such, **the removal of any brick walls would require new steel beam, column, and footing replacements.**

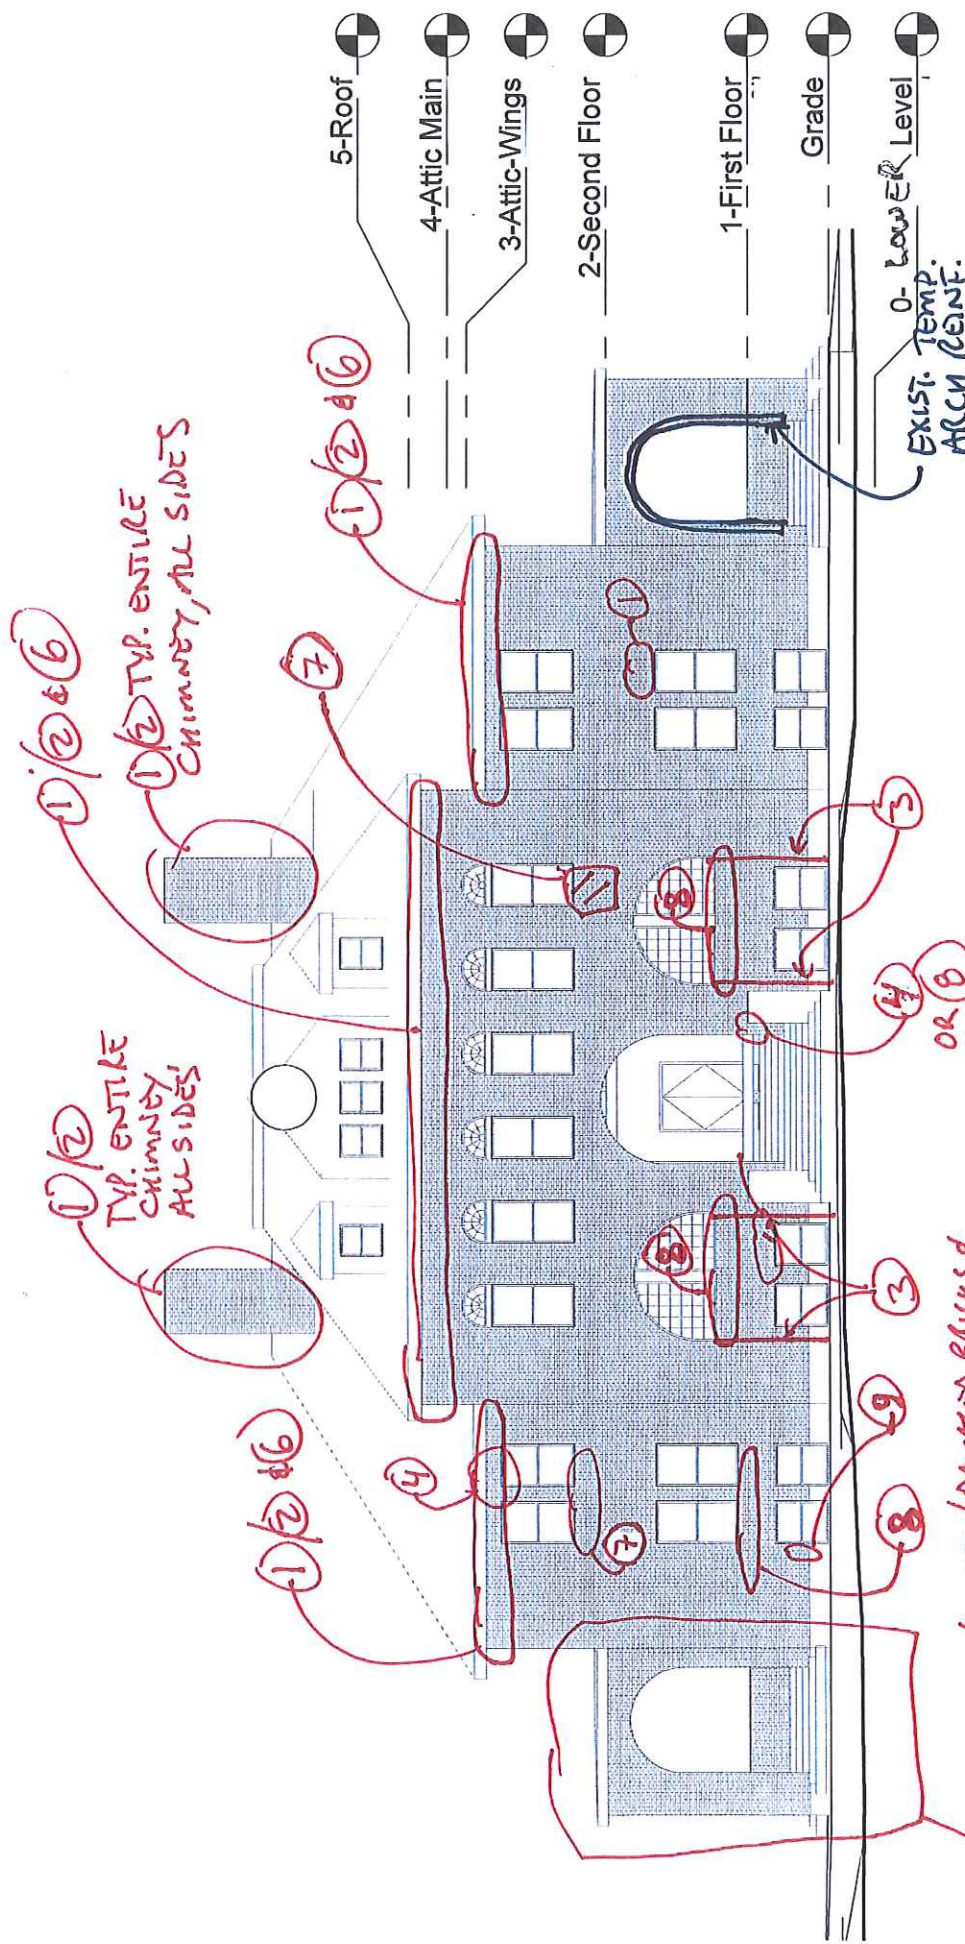
ALL ELEVATIONS: Investigate existing connection of veneer to backup. Smaller dimensions of veneer brick, combined with likely larger brick dimensions for backup brick, likely resulted in infrequent connection between veneer and backup. Assume pinning of veneer to backup will be required.

- ① Repoint.
- ② Re-set or pin loose or shifted bricks or stone sill.
- ③ Caulk joints.
- ④ Reset, replace, and/or stitch brickwork at cracks or damaged bricks.

- ⑤ Possible localized bow or bulge in wall. Will require further investigation into cause. Assume pinning, brick resetting, and re-detailing of connection of interior framing to exterior wall. A lift inspection should be performed and the masonry sounded out with a hammer.

- ⑥ Further investigation is required to determine whether roof thrust loads or rusting embedded metals are causing brick movement.
- ⑦ Consider flashing under the brick soldier course. Reset bricks. (Water is soaking into joints, combined with no brick weight above this level at windows but brick weight from above on adjacent bricks, causing bricks at this location to bow upward).

- ⑧ Pull bricks out and perform a deep re-packing and resetting of bricks. (Issue with brick that readily absorbs water and swells, in combination with a lack of window drip, in contact with stone sill that does not readily absorb water).

- ⑨ Mortar repair cracks. (Issue of brick moisture growth/swelling alongside a stone foundation that does not expand, leading to friction in the joint between the two differing materials).

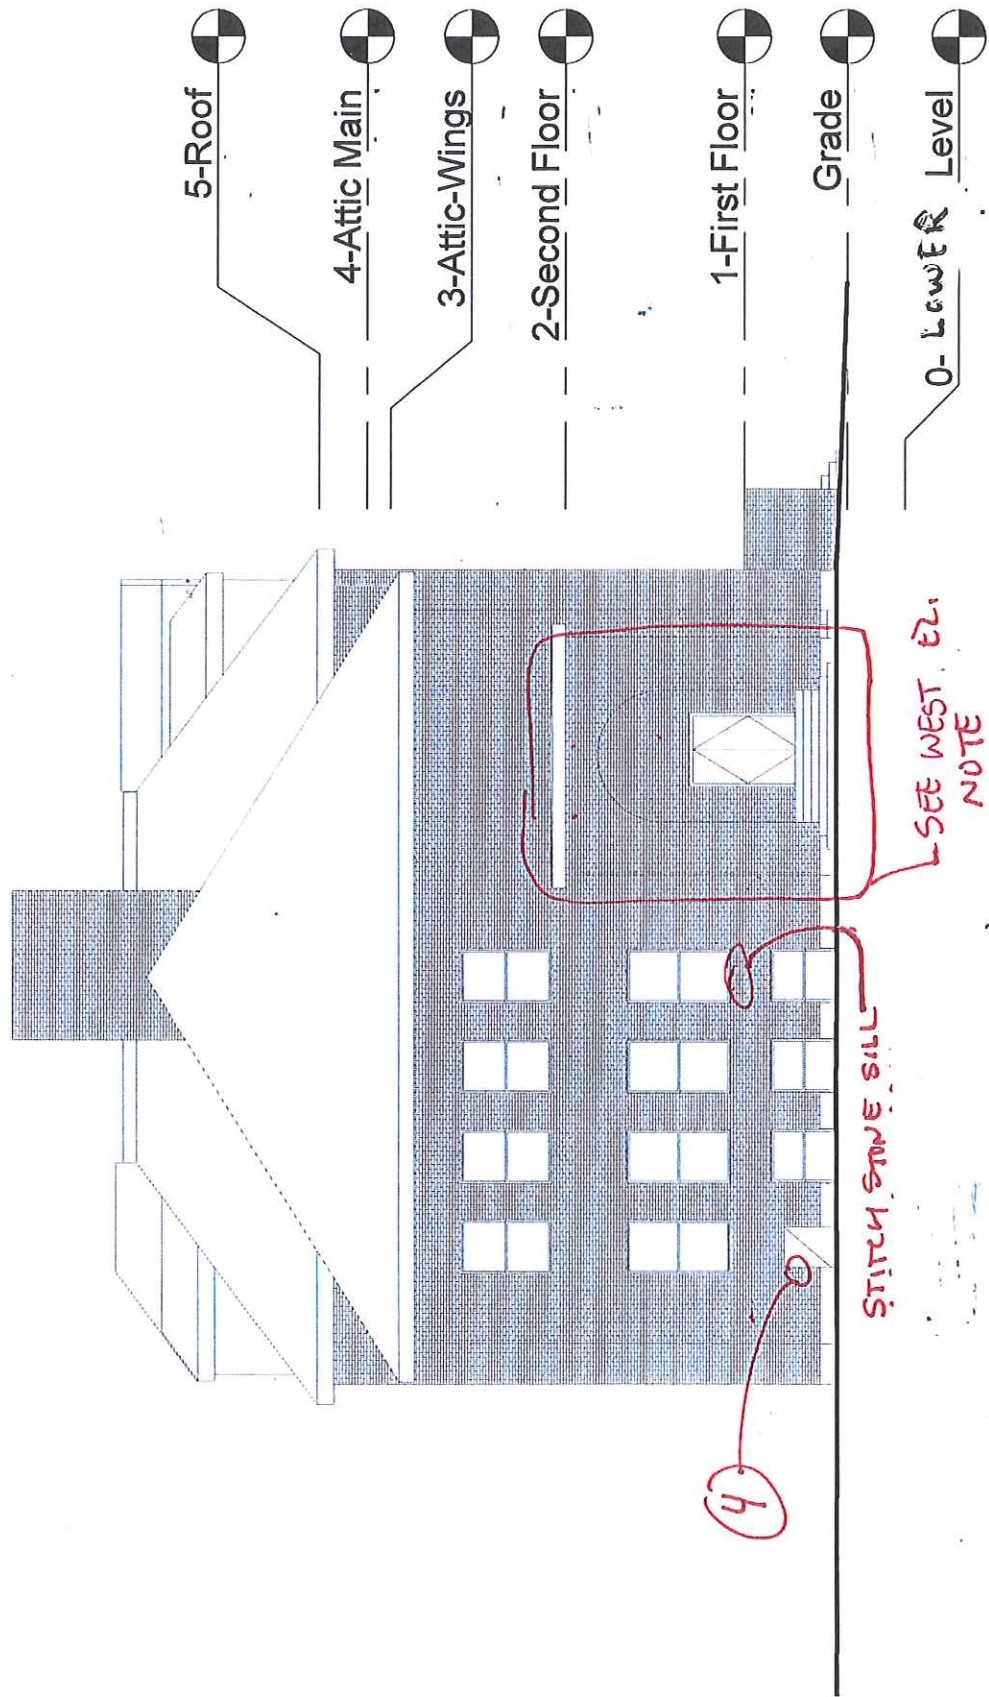
NORTH ELEVATION

At the south portico, existing steel reinforcing of the 3 arches was observed. A previous engineer's report noted the need for temporary reinforcing of the arches. Our elevation markups note using similar reinforcing at the north

portico, which is exhibiting serious cracks in the arch. If the steel reinforcing at the south portico was intended to be temporary, then a new reinforcing scheme will need to be developed for both porticos. Assume extensive brick re-setting and repointing at the north portico, along with temporary arch shoring and permanent tension rods at the spring of the arches at all arches in both porticos.
